# Arboricultural Constraints Appraisal

Site Address: **Ferens Hall  
Cottingham  
Hull  
HU16 5SE**

Report Ref: **FHH02-25**

Client: **Savills**

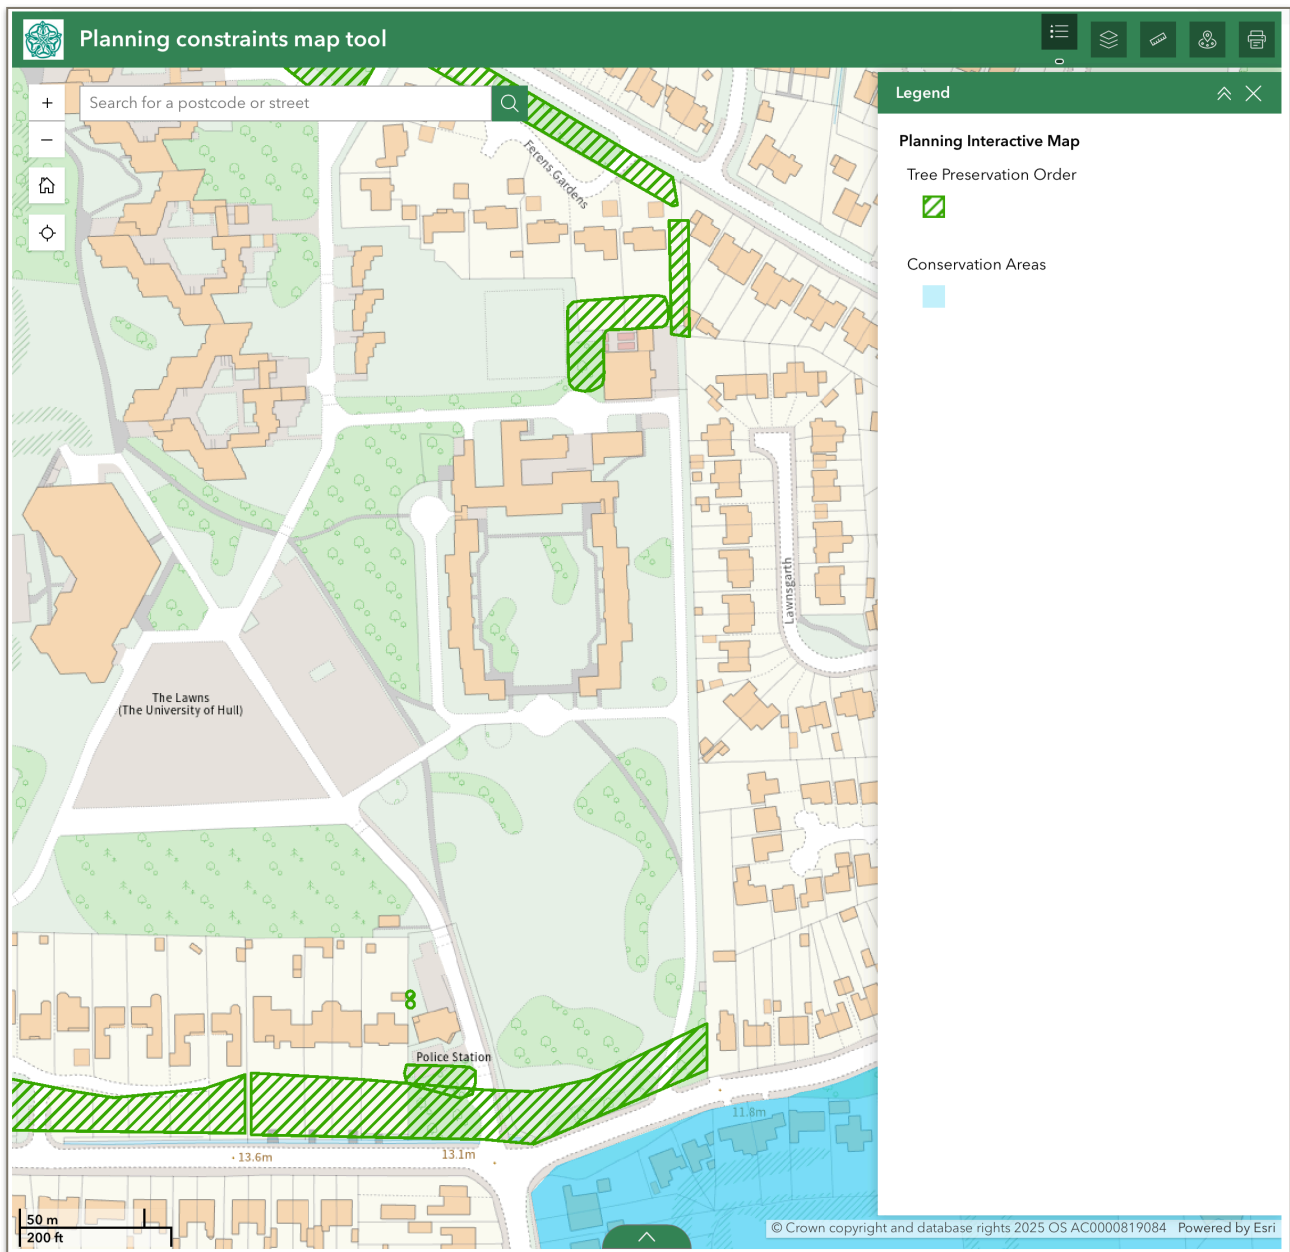
**Screenshot 1:** An image taken from the East Riding of Yorkshire Council's planning constraints mapping tool was taken on 13 January 2026. This indicates that two Tree Preservation Orders (TPOs) affect the site.

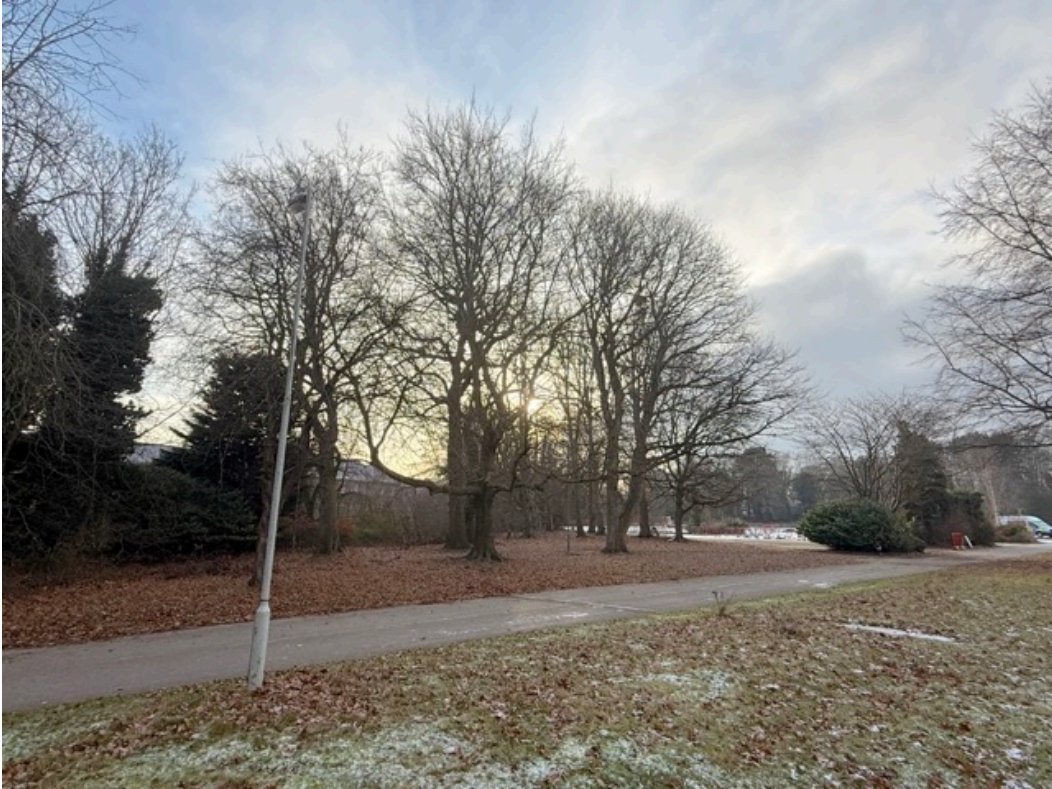
Woodland compartment W3 contains a high concentration of high-quality trees that are generally well spaced and in good condition. This area represents a high-value arboricultural asset, contributing both aesthetic appeal and a mature, established green screen and shelterbelt.

W3	Mature	Mixed	22	570	6, 6, 6, 6	3.5 W	2.5	Normal	Mixed broad leaf woodland with mature well-spaced specimens including Sycamore, Poplar, Hornbeam, Oak, Horse Chestnut, Cedar and Birch. Some minor regions of scrubby understory growth, but mostly open with trees in good condition.	-	>40	A2	6.8
T126	Mature	Birch ( <i>Betula pendula</i> )	16.5	400	3, 4.5, 3.5, 2	-	-	Poor	An almost entirely dead tree with very limited viable bud sites.	Fell and replace.	10<	U	4.8
T127	Mature	Birch ( <i>Betula pendula</i> )	17	330	2, 1, 3, 2	-	-	Poor	An almost entirely dead tree with very limited viable bud sites.	Fell and replace.	10<	U	4.0
G128	Mature	Sycamore ( <i>Acer pseudoplatanus</i> )	19.5	650	7, 7, 7, 7	5 S	7	Normal	A row of four Sycamore trees of roughly similar age and size characteristics all stems are heavily clad in Ivy.	Sever and remove Ivy.	20>	B2	7.8
G129	Semi Mature	Mixed	6-15	200-300	3, 3, 3, 3 ave.	-	3	Poor	Understory trees including Horse Chestnut, Hawthorn, Laburnum and Cherry all heavily clad in Ivy located within a scrub type area.	Sever and remove Ivy.	10>	C2	3.6

**Figure 6.** Northern aspect of W3.

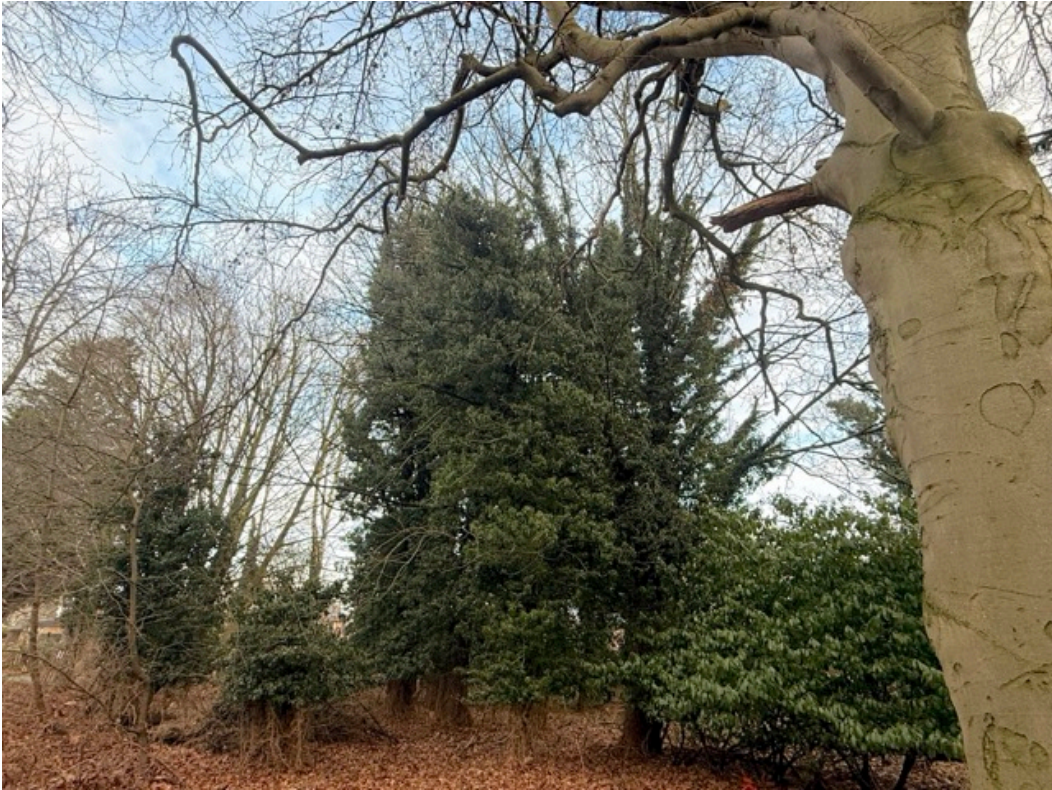
The area comprising H8, H9, G24, T118, T119, G128, G129, G130, T131, T132 and G133 has received little to no active management in recent years, with several trees now growing in proximity to buildings or making direct contact with them. In addition, Ivy growth is widespread and suppresses parts of the understory, reducing structural clarity and long-term tree condition. Within this area, there are two Category U Willow trees which, despite having a limited safe remaining lifespan, provide some ecological value due to the presence of cavities and decay features.

**Figure 7.** G128 is heavily clad in Ivy.

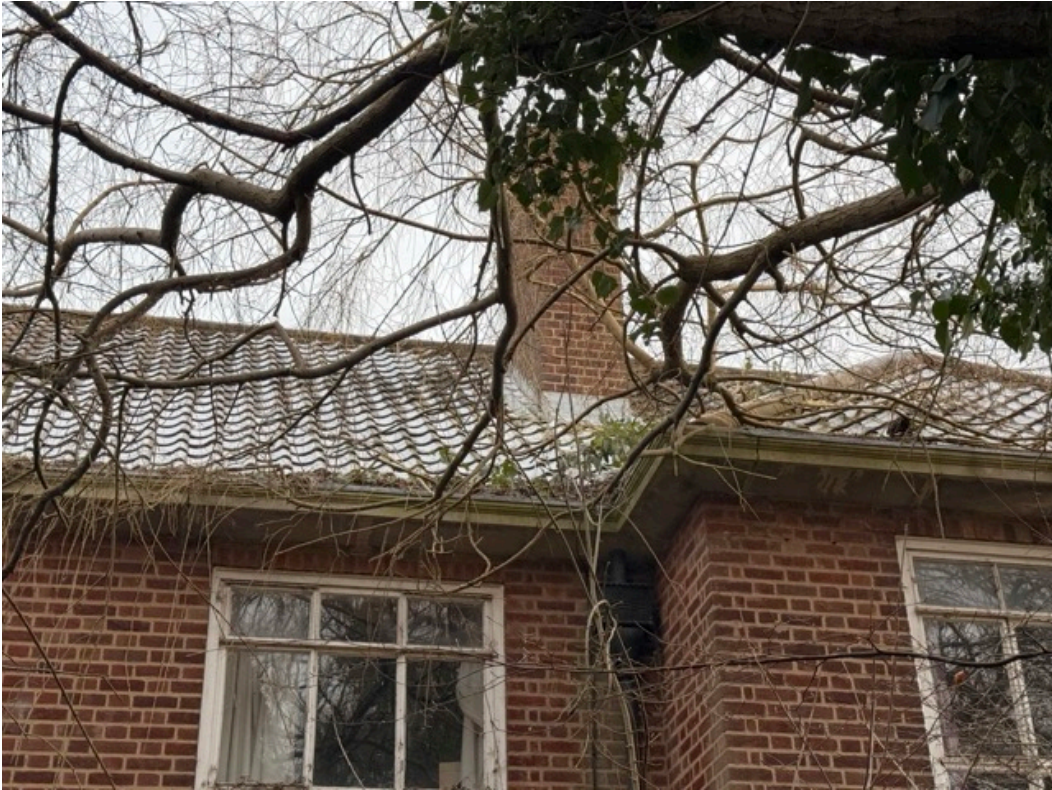
**Figure 9.** T118 is in contact with the neighbouring building.

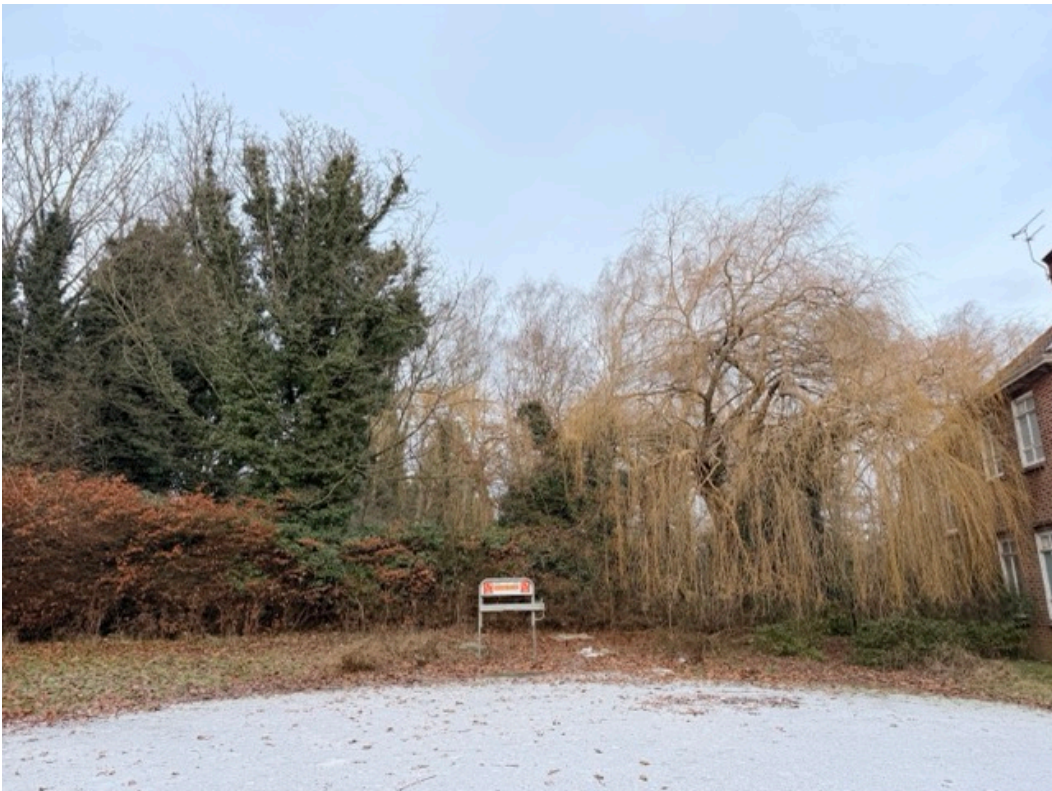
**Figure 10.** T132 (left) is heavily clad in Ivy, and T118 (right) with H8 below.

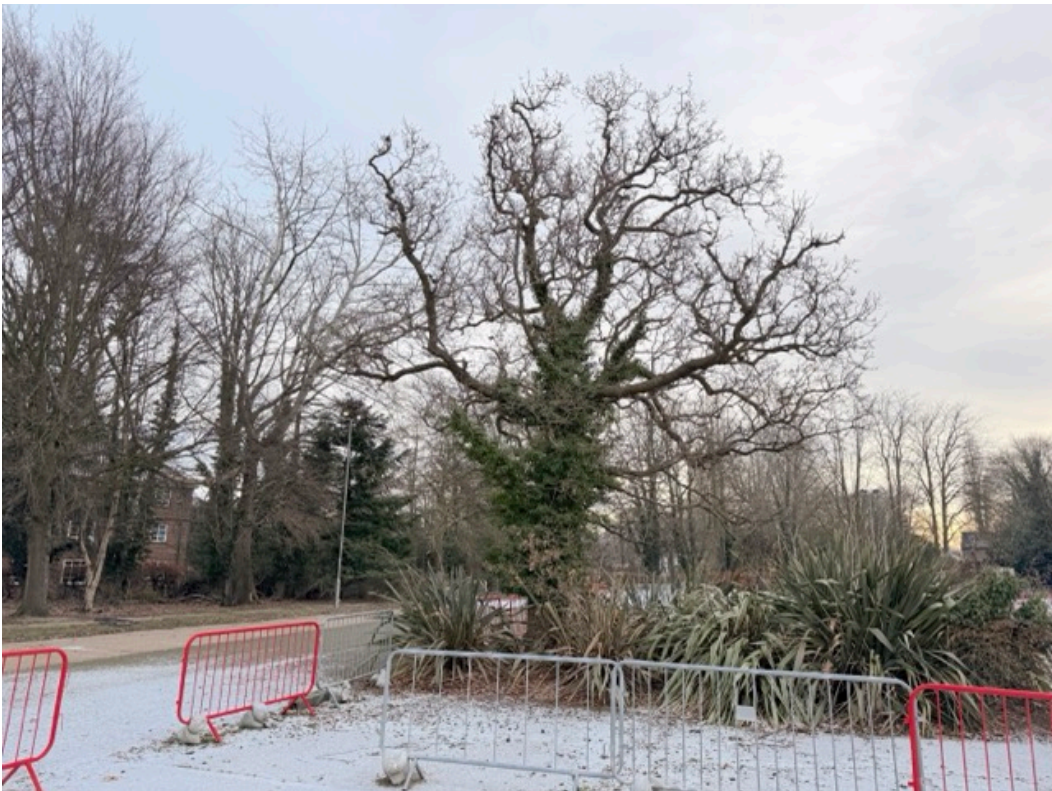
T83	Over Mature	Oak ( <i>Quercus robur</i> )	10.5	650	4.5, 4.5, 5, 5	2.5 E	2	Poor	Ivy-clad stem, low vigour with minor dieback at the crown. Limited soil rooting volume and high competition for nutrients.	Improve the soil routing volume by adding a layer of organic mulch	>20	B1	7.8
T84	Mature	Horse Chestnut ( <i>Aesculus hippocastanum</i> )	12.5	580	5.5, 6, 5.5, 6	3 S	1.5	Fair	Minor bleeding lesions and cambial necrosis. Canopy is in good health. Significant limb removal at 3 m north. High likelihood of decay entering the stem, limiting long-term viable lifespan.	-	>10	C2	7.0
T85	Early Mature	Beech ( <i>Fagus sylvatica</i> )	19	540	4, 4, 3.5, 6	3 N	2	Normal	Tall slim specimen with a single leader.	-	>20	B2	6.5
G14	Semi Mature	Larch ( <i>Larix decidua</i> )	14	330	5, 5, 5, 8	4 W	4	Normal	18 Larch trees in close proximity. Includes two small dead stems. Outer trees have some long lateral branching. Stems range from 150-320 dbh. However, most are around 200.	Remove dead stems	>20	B2	4.0

**Figure 14.** T83 with W3 to the left of the image.

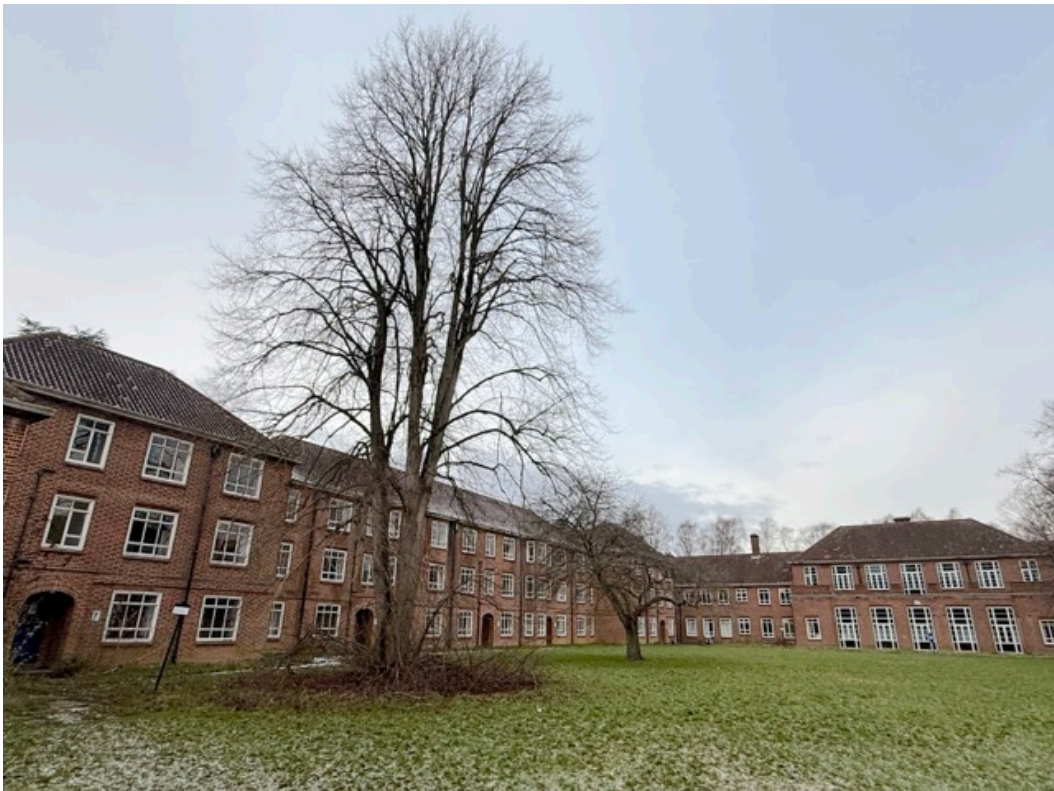
T115	Mature	Ornamental Cherry ( <i>Prunus</i> )	11	580	5.5, 6, 6.5, 6.5	2.5 NE	2	Normal	Grafted specimen at 2m with large reverted stem growing from 2m south west.	Potential to reduce reverted limb to prevent it from outcompeting the rest of the tree.	>20	B1	7.0
T116	Mature	Ornamental Cherry ( <i>Prunus</i> )	7	820	4, 5.5, 5.5, 4.5	3 S	2	Normal	Grafted specimen at 2m in excellent condition.	-	>40	A1	9.8
T117	Mature	Hybrid Lime ( <i>Tilia x europaea</i> )	18	730	5.5, 7, 6, 7	6	2	Normal	Epicormic growth throughout the lower crown and around the base. Hanging branch and minor deadwood.	Remove deadwood and epicormic	>40	A1	8.8
T118	Mature	Golden Weeping Willow ( <i>Salix x sepulcralis</i> 'Chrysocoma')	10	710	5, 7, 6, 5.5	1.5 S	Ground Level	Normal	Historically pollarded at 7m. Has now become lapsed with lateral branches in contact with the neighbouring building.	Re-pollard	>10	C2	8.5
H8	Early Mature	Beech ( <i>Fagus sylvatica</i> )	1.5/2	<75	N/A	Ground Level	Ground Level		Managed hedgerow in good condition. The Northern region contains Hawthorn and has become unmanaged.	-	>10	C2	1.0

**Figure 20.** T36 (left) with T115 (right).

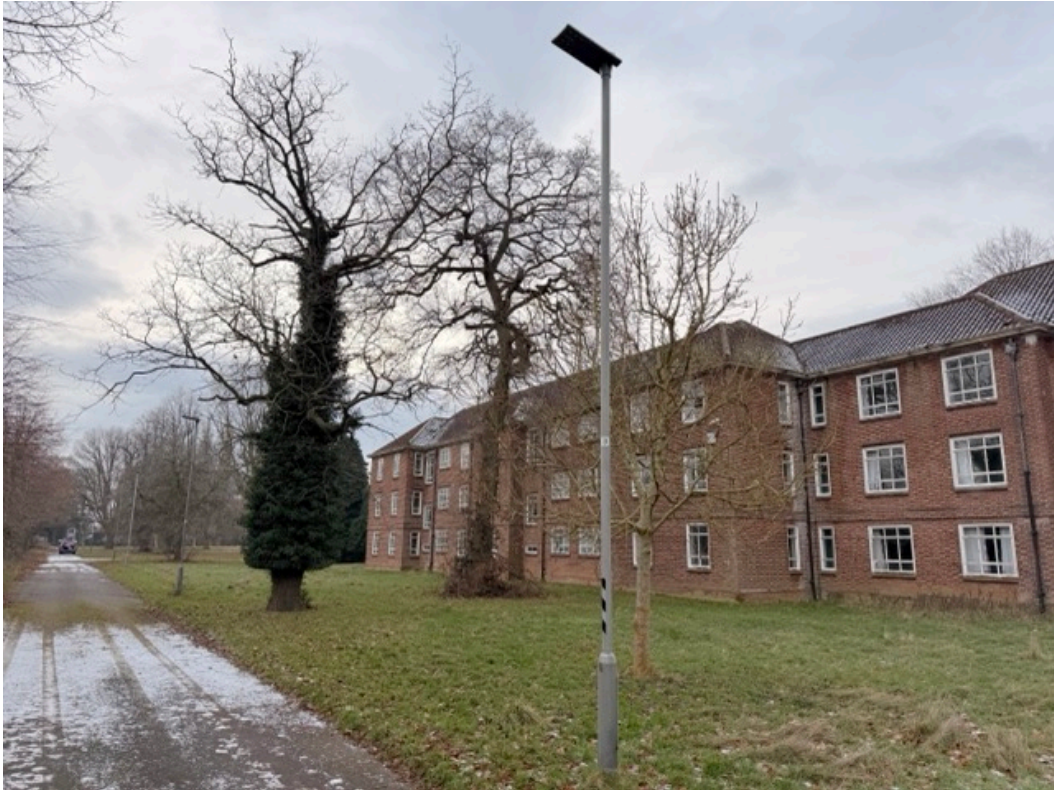
T108	Mature	Oak ( <i>Quercus robur</i> )	19	810	7.5, 7.5, 7.5, 5.5	8S	2	Normal	High volume of epicormic growth with deadwood and broken branches within the canopy.	Remove deadwood and hanging branches.	>40	A2	9.7
T109	Mature	Oak ( <i>Quercus robur</i> )	15	700	7, 4.5, 5.5, 4	6 N	4	Poor	Squat specimen with reduced vigour and minor deadwood at the Crown extremities. Ivy growing on the stem.	Remove Ivy	>10	C2	8.4
T110	Young	Golden Ash ( <i>Fraxinus excelsior</i> 'Jaspidea')	5.5	180	3, 3, 2.5, 3	2 S	2	Normal	Newly established tree in good condition. No evidence of Ash dieback infection observed however given the probability of infection higher classification cannot be justified	-	>10	C1	2.2

**Figure 25.** T110 (foreground) with T109 (left) and T108 (right) in the background.

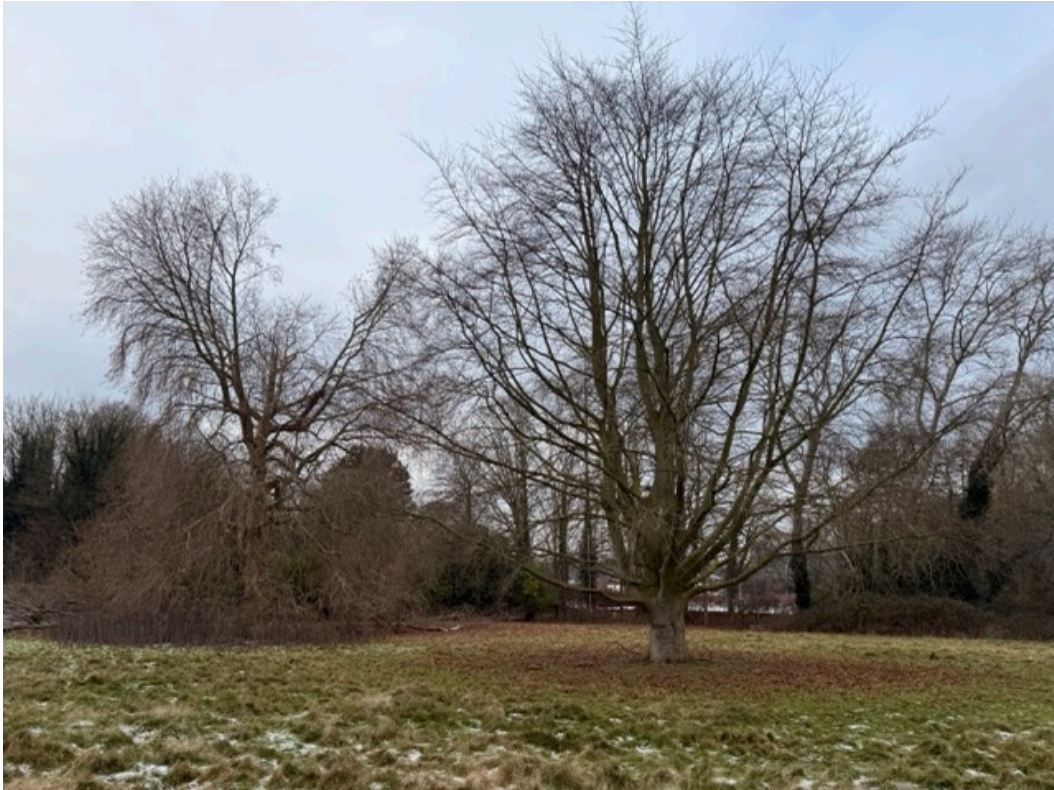
T86	Mature	Oriental Plane ( <i>Platanus orientalis</i> )	25	1130	10, 10, 7, 9	1 E	Ground Level	Normal	Multiple heavy limbs which swoop downwards. Limb loss and removal at 6m west with canopy development. Good structural growth around damage.	-	>40	A1	13.6
T87	Mature	Beech ( <i>Fagus sylvatica</i> )	18	970	8, 8, 8.5, 8.5	2 W	2	Normal	Multiple stems from 1m, tight unions, but considered adequate with minimal evidence of strain at the unions.	-	>20	B1	11.6

**Figure 29.** T86 (left) and T87 (right) with W20 in the background.

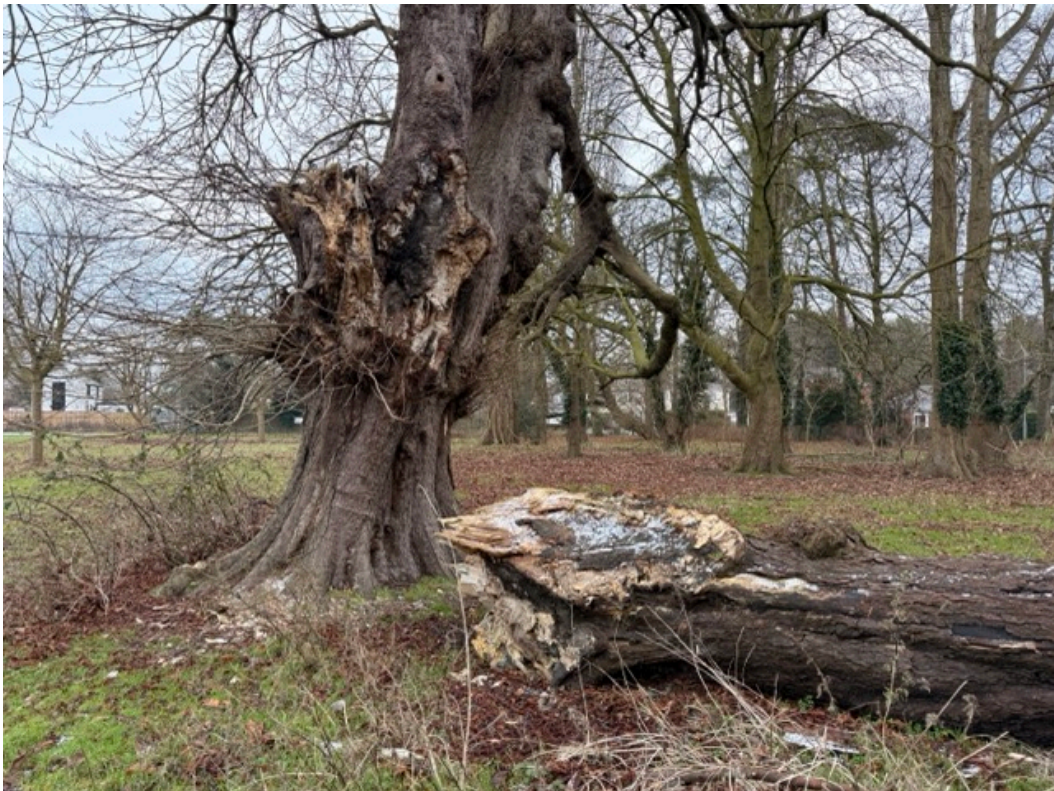
**Figure 32.** T89 with a large limb failure.
